MEMO 34
IMPACT SOUND TRANSMISSION

Dato: 23.06.2022
Siste rev.: 28.06.2022
Dok. nr.: K3-10/13

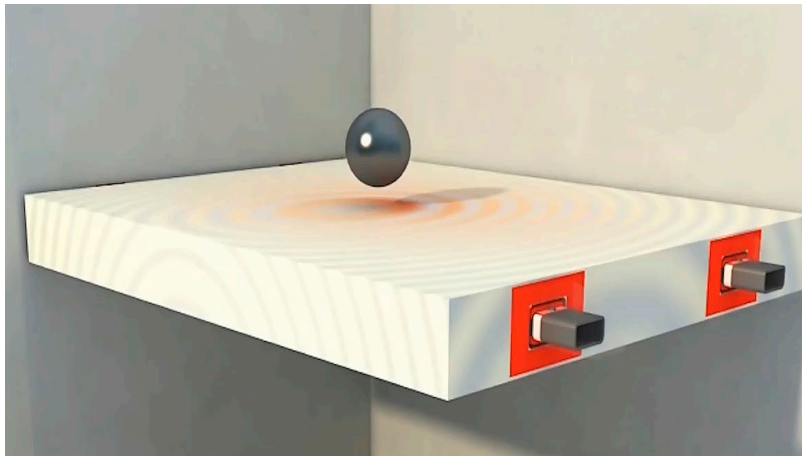
Stepsound from concrete stairs without sound reducing efforts

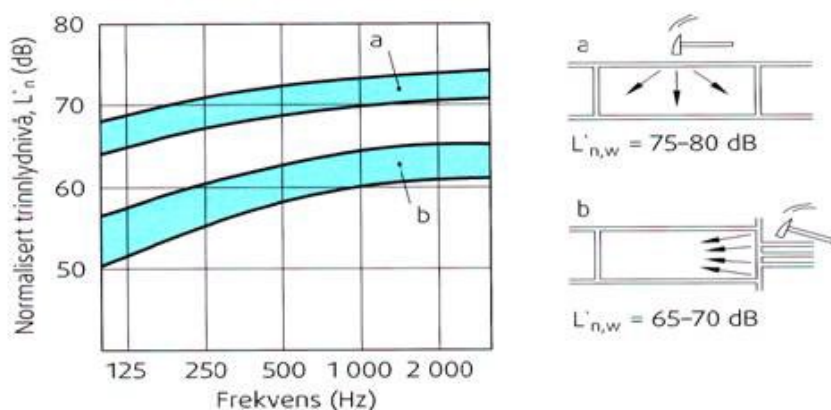
Limit values for apartments

Room type	Class B dB	Class C dB
Between residential units, a unit from common areas / common hallway / stairwell	48	53
To a unit from toilet, storage, balcony, terrace etc.	53	58
To a residential unit from business, service business, public garage, roof terrace etc.	43	48

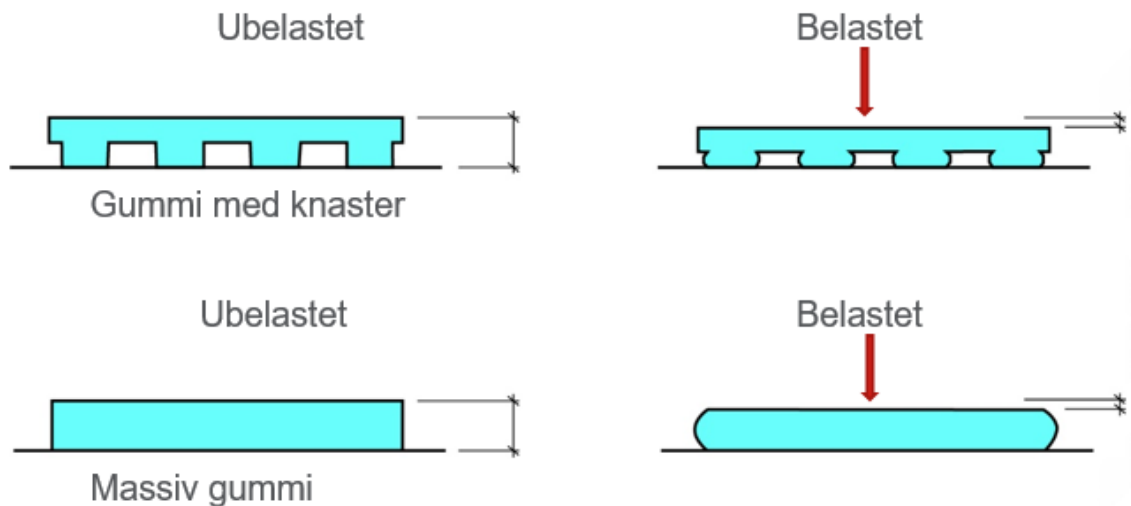
The principle for effective sound reduction

Our experience is that if you want to have good sound reduction, you have to use soft rubber eg 58 shore.

Then you must have an area of 250 mm² pr. kN breaking load.

To reduce impact sound you need square
200-250 mm²/ kN ultimate load.

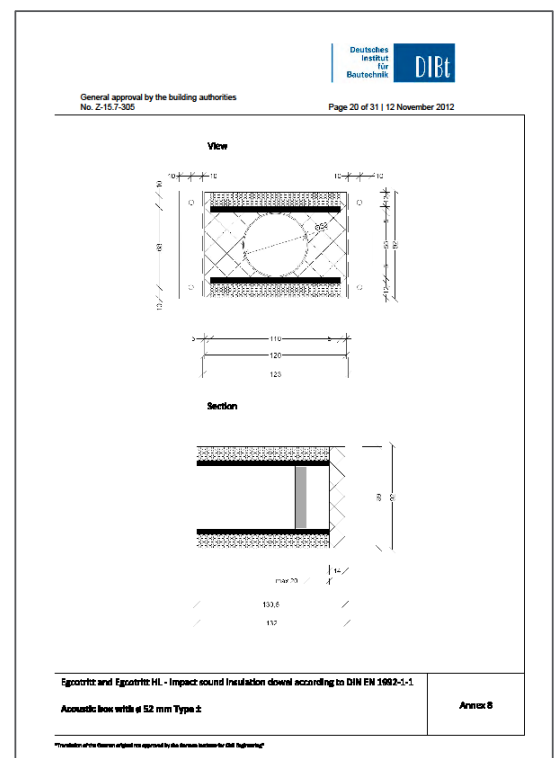
Area : $115 \times 110 = 12650 \text{ mm}^2 / 60 \text{ kN} = 210 \text{ mm}^2 / \text{kN}$
TSS 102 = 25 dB. 100 kN

Area : $25000 \text{ mm}^2 = 250 \text{ mm}^2 / \text{kN}$

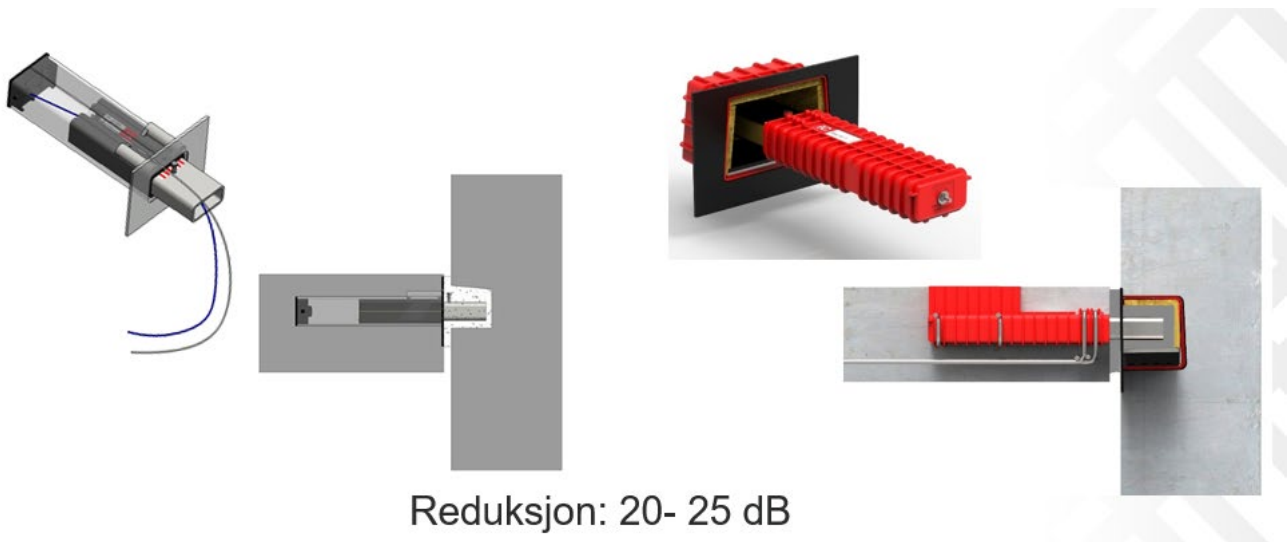
Recomended solution for apartments TSS 102 orr RVK/TSS with IC Box SRU

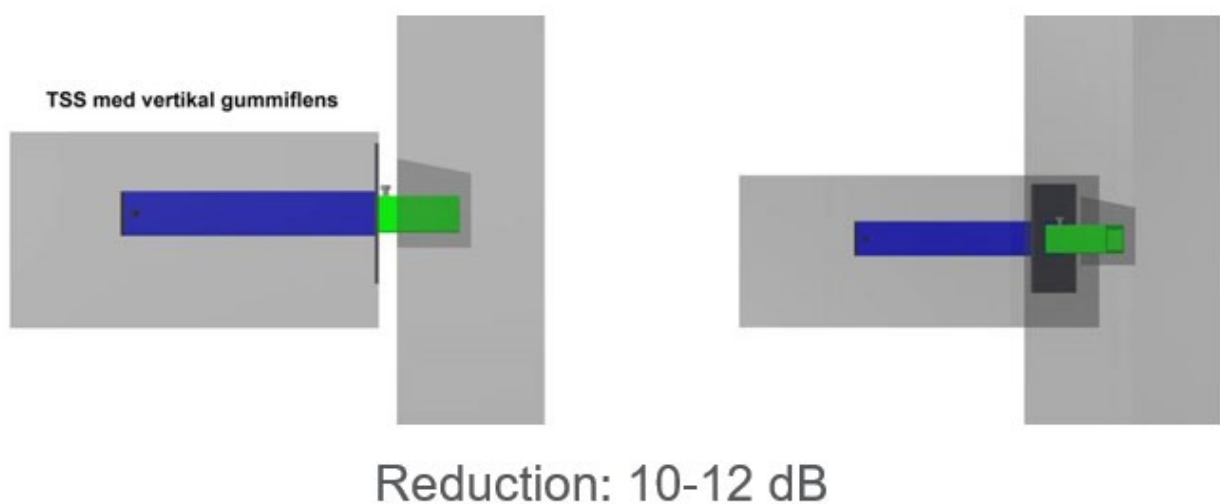
Recomended solution for offices and public buildings. TSS with vertical rubber flange.

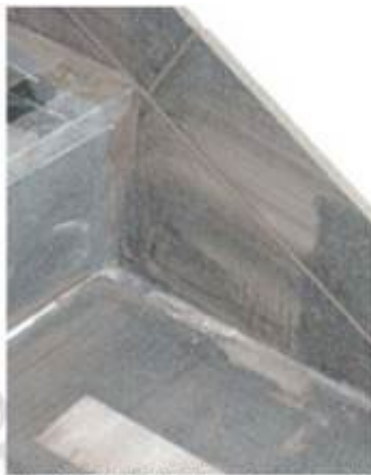
Foto 15. Detalj skiferfliser på trapp og sokkellist

1. No casting wider than vertical rubber flange
W= 250 x H=200
2. Elastic joint between landing and wall minimum
10 mm
3. Tiles must not be in contact with the wall,
minimum 10 mm joint
4. base tiles forbidden

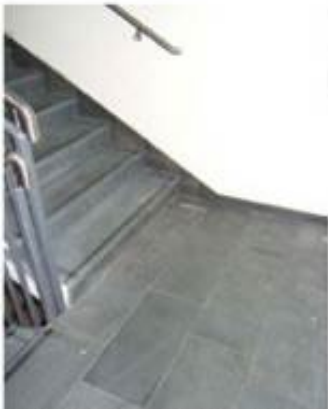
Foto 14. Detalj skiferfliser på trapp og sokkellist

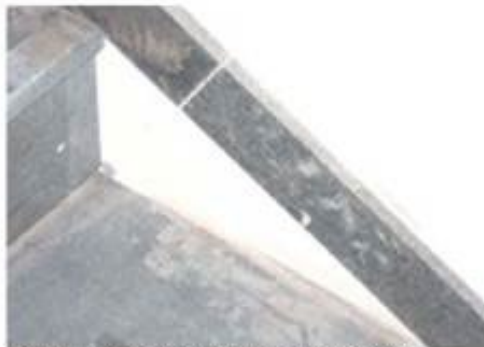
Foto 16. Detalj skiferfliser på trapp og sokkellist
Et område manglet skifer og avslørte lim som rent ned i fugen.
